CUBA LAKE DAM

**ALLEGANY COUNTY, NEW YORK
INVENTORY NUMBER NY 455**

**PHASE 1
INSPECTION REPORT
NATIONAL DAM
SAFETY PROGRAM**

**L. ROBERT KIMBALL and ASSOCIATES
615 W. Highland Ave. Ebensburg, Pa.**

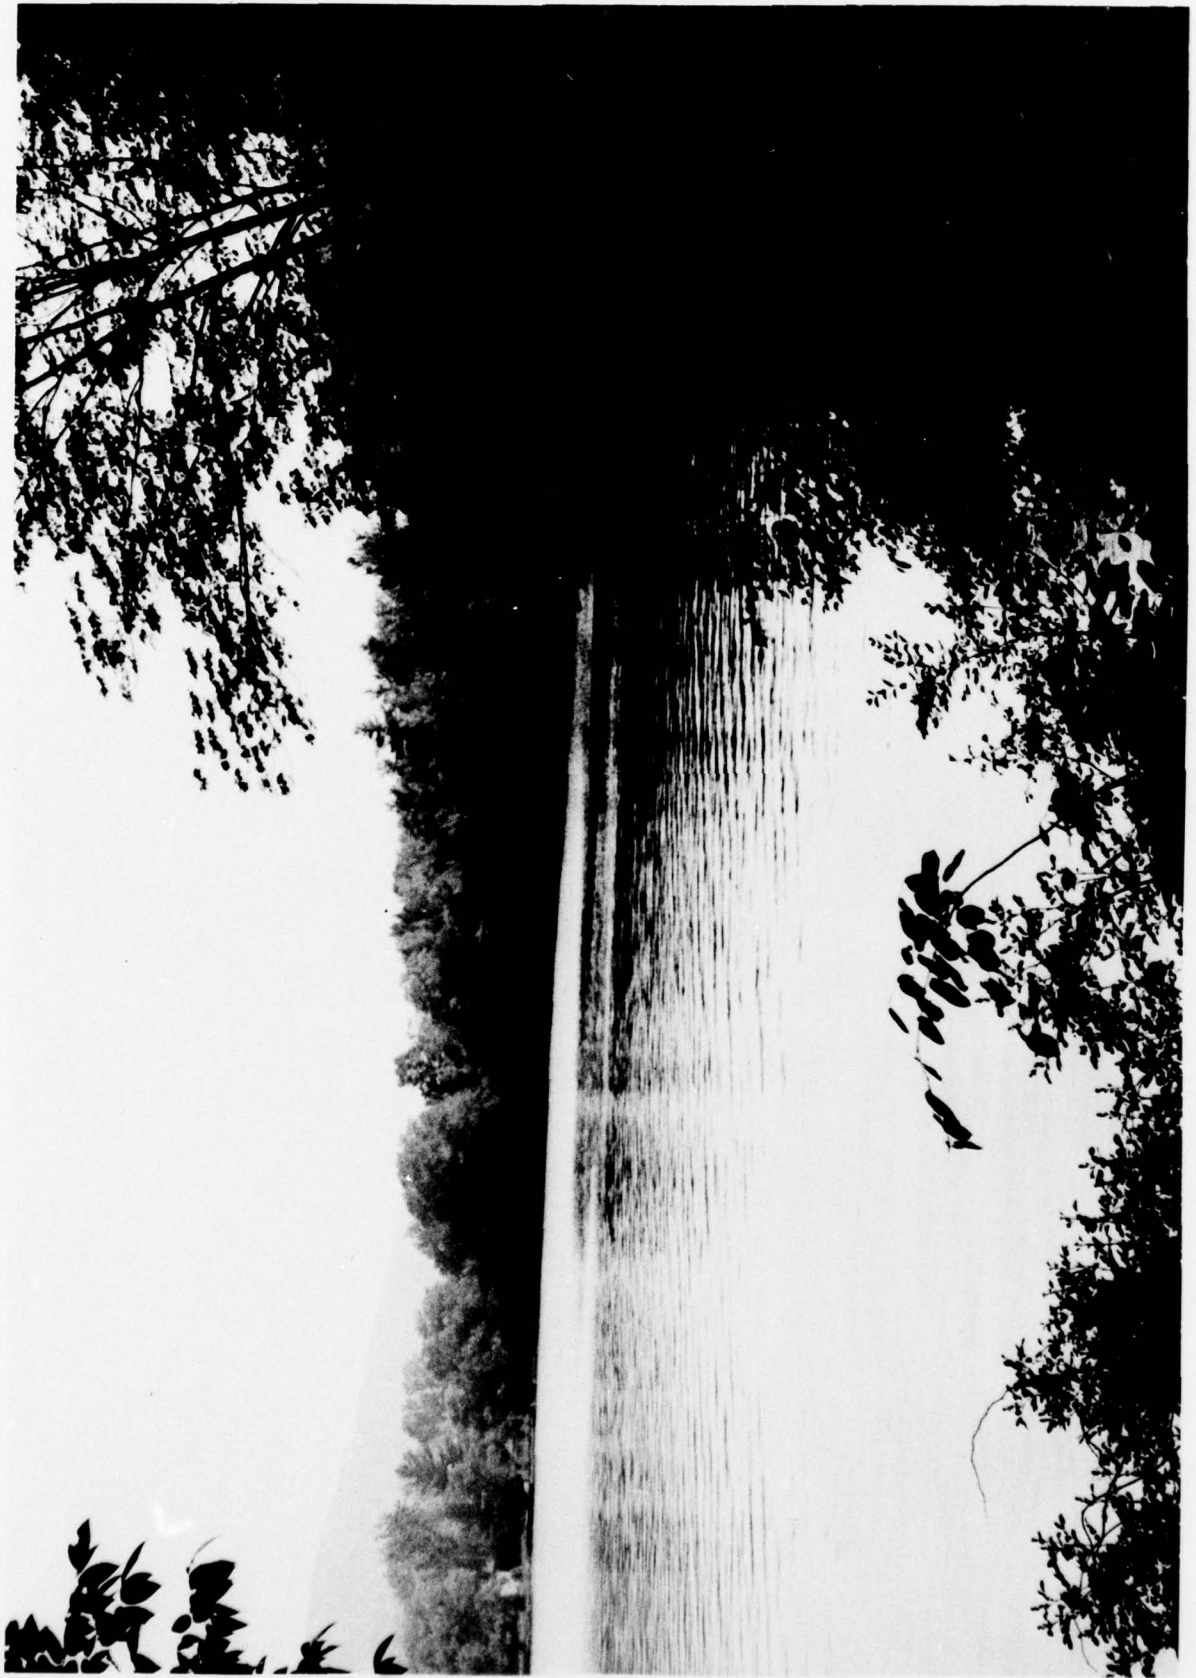
PLATE 1

1. View of upstream face from right abutment.
2. View of upstream face from left abutment.
3. Upstream face showing steep slope, displaced rip rap, and movement (noted by trees).
4. Upstream slope showing rip rap, washed out areas, and gabions.
5. Downstream slope from cemetery (downstream) showing tree growth, small retaining wall at toe near cemetery.
6. View of emergency uncontrolled spillway and gated spillway in foreground.
7. Downstream view of gated spillway.
8. Downstream channel showing highway bridge.

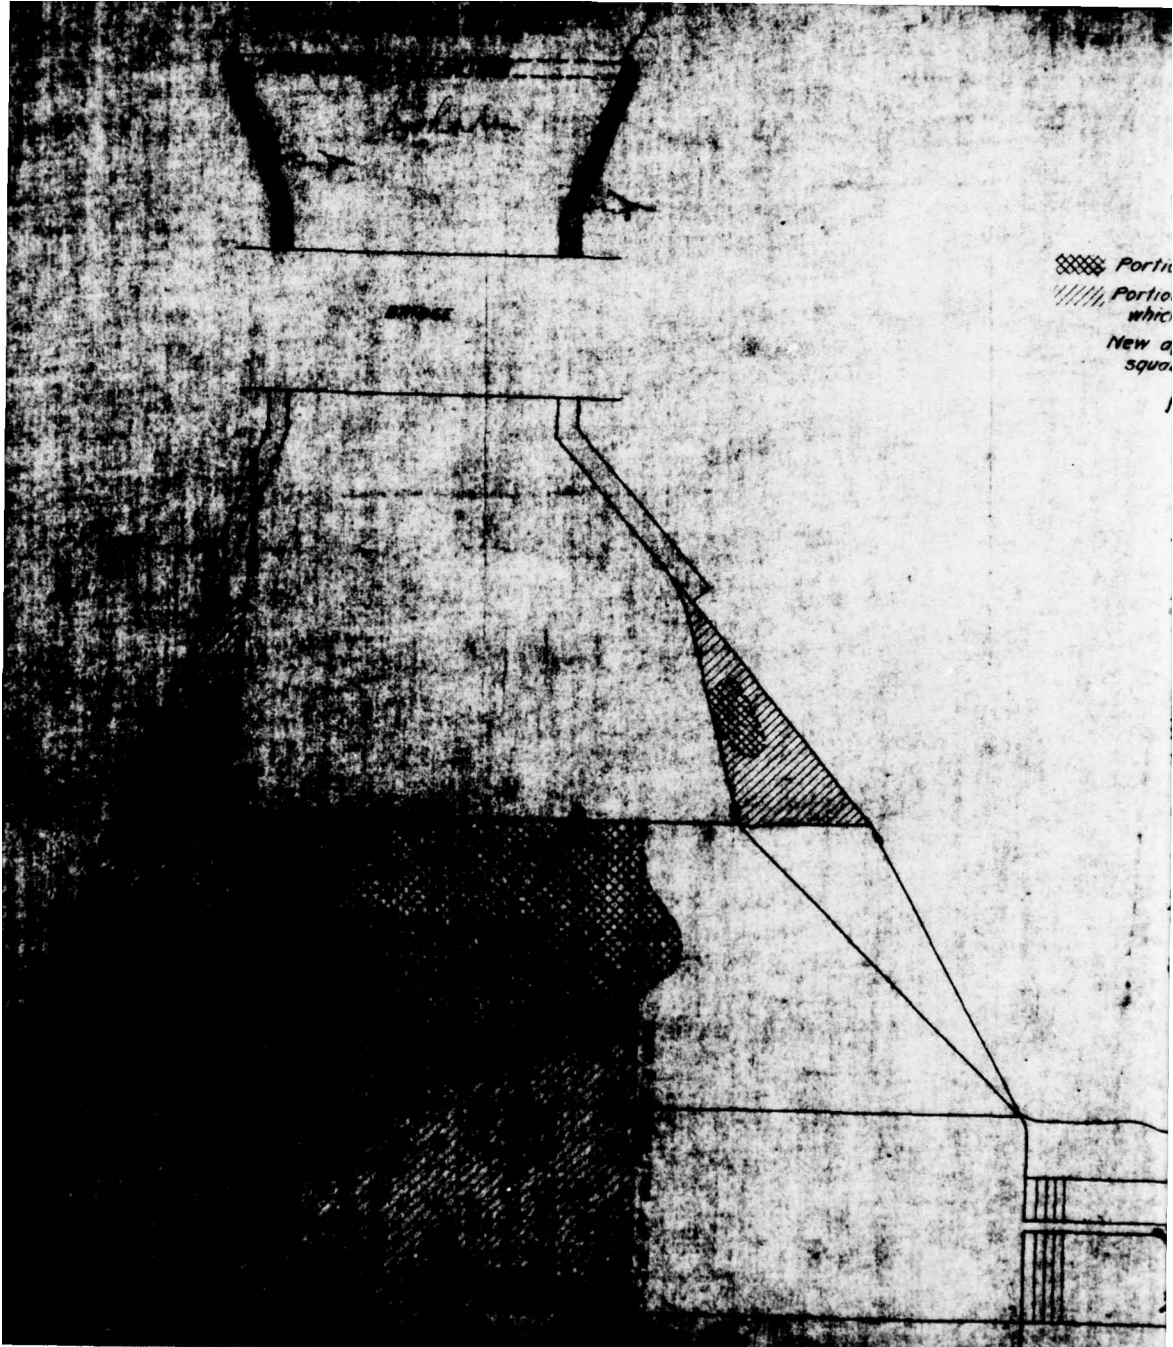
PLAN OF REPAIRS TO DAM

XXXX Portion of apron washed out.

//// Portion of apron found to be undermined
which was removed.
